Bobcat/Bunton Service Bulletin

Product Type: ZT2

Bulletin No: C-012-05

Crankshaft Spacing

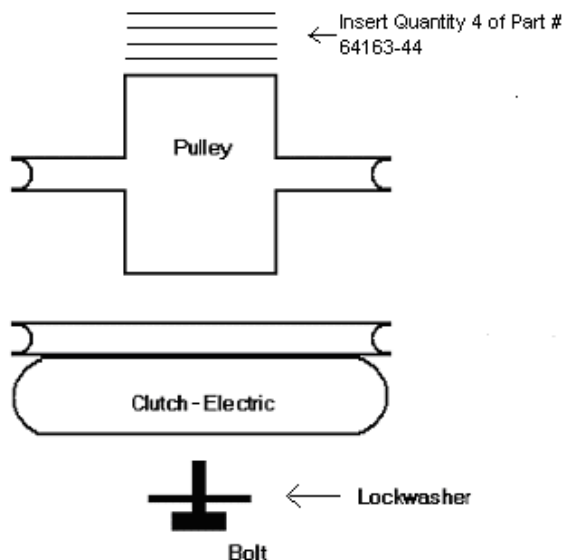
It has come to our attention that the crankshaft spacing may not be correct.

Remove the clutch-mounting bolt from the center of the crankshaft. Remove the Clutch and drive pulley. Install Machinery Bushings 64163-44 (quantity of 4) above the Pump Drive Pulley. Reinstall the clutch and torque the clutch-mounting bolt to 50 ft/lbs.
