Jacobsen Service Bulletin

Product Type: Z FASTCAT PLUS ES

Bulletin No: C-025-04

Crankshaft Spacing

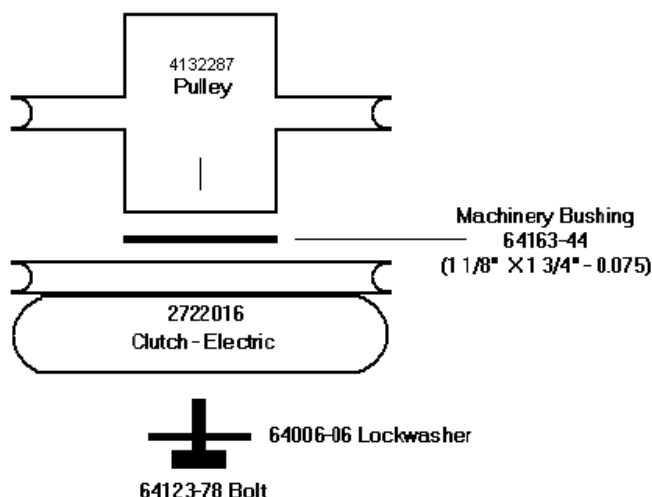
It has come to our attention that the crankshaft spacing may not be correct.

Remove the clutch mounting bolt from the center of the crankshaft. Remove the Clutch 2722016 and install a Machinery Bushing 64163-44 between the clutch and Pump Drive Pulley 4132287. Reinstall the clutch and torque the clutch mounting bolt to 50 ft/lbs.
