May 2002

### Spindle Pulley Clamping

**Models Affected:**  
**933405, 933406, 933010**

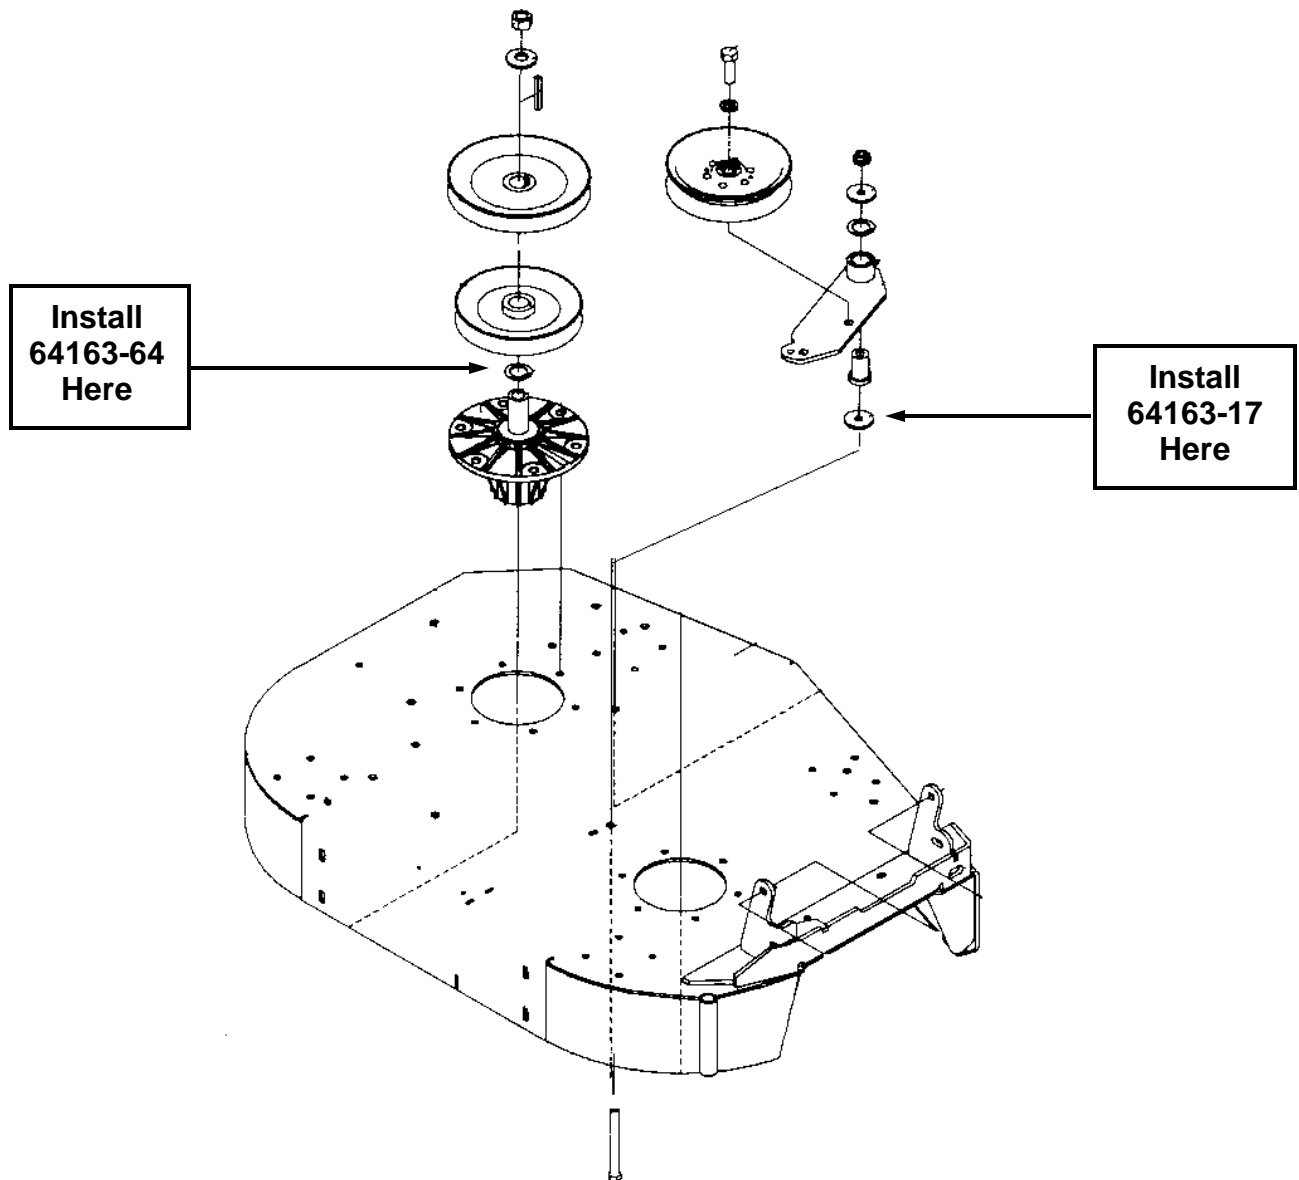
# 36" Fixed and Floating Decks

It has been reported from the field that we have had some left hand spindle pulleys loosen up. It has been confirmed that on some machines the spindle shaft may stick above the upper pulley hub on the left hand spindle assembly. In this state, the pulleys are not clamped properly allowing them to eventually wallow out the pulley bore, key and key way.

Remove the left-hand drive pulleys and install a **64163-64** machine bushing between the spindle top and the bottom pulley 2308140. Retighten the blade bolt to 70 ft lbs. Remove the deck belt idler assembly and install a **64163-17** machine bushing between the 2720718 pin - pivot and the deck top. Please see page 2 for diagram.
