April 2001

Hour Meter Wiring

Models Affected: 942211

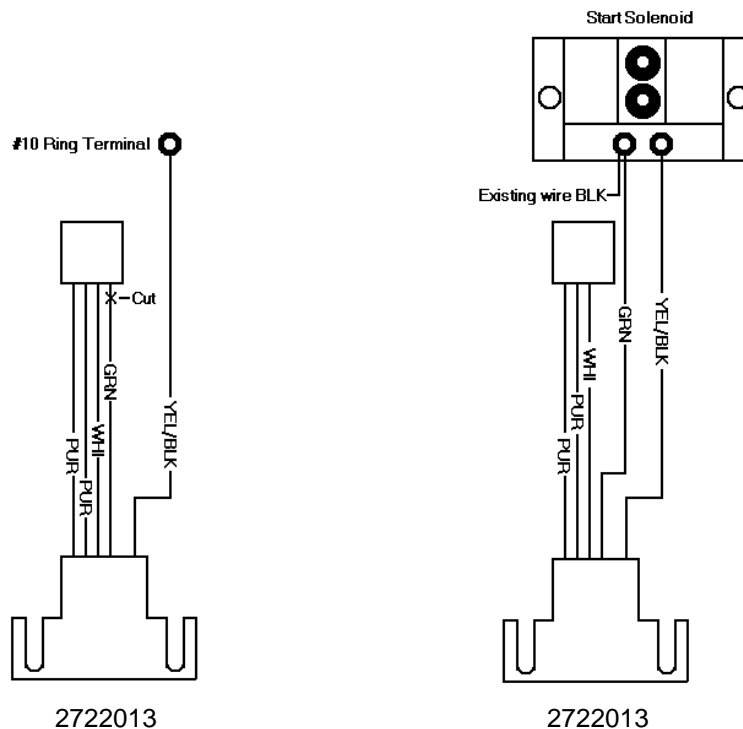
It has come to our attention that the Hour Meter **48030N** on the 218 ES is not properly wired.

Disconnect the battery and locate the jumper harness **2722013** at the left-side of the engine. Cut the green wire at the white connector end of the harness. Install the green wire into the auto-loom with the yellow/black wire routed to the engine start solenoid **38665**. Install a #10 ring terminal to the green wire and install it with the black wire on the engine start solenoid. Reconnect the battery, start the unit and check that the hour meter is running.
