April 2001

Mandatory Update

Crankshaft Spacing

Models Affected:
942211

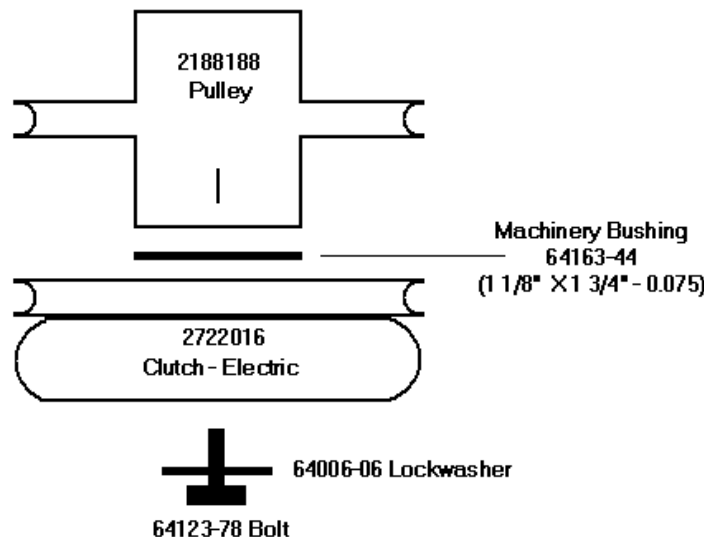
It has come to our attention that the crankshaft spacing may not be correct on the 218 ES units. Please update units in the field as soon as possible. Crated units can be updated at time of setup.

Remove the clutch mounting bolt from the center of the crankshaft. Remove the Clutch **2722016** and install a Machinery Bushing **64163-44** between the clutch and Pump Drive Pulley **2188188**. Reinstall the clutch and torque the clutch mounting bolt to 50 ft/lbs.
