May 1998

### ZT200 Wheel Motor Mounting Bolts

#### Models Affected: 942215, 942212

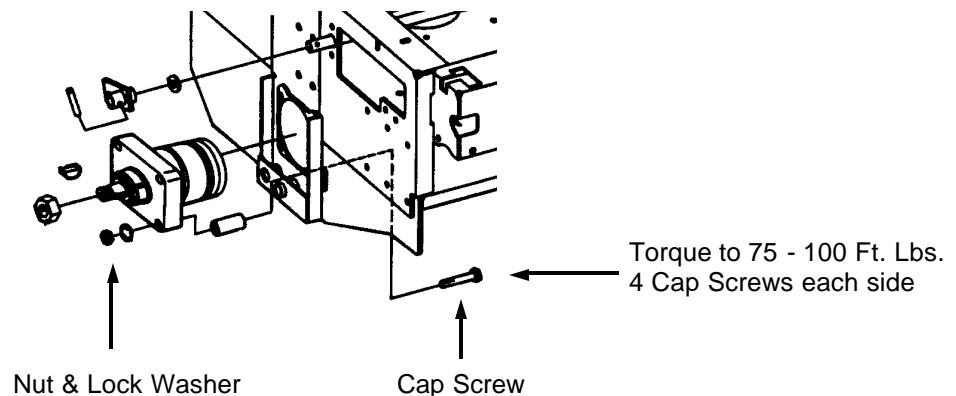
We have had reports from the field that on some new units the wheel motor mounting cap screws have come loose, allowing the wheel motor to come loose from the machine. After investigating we found a faulty torque gun on the assembly line.

New machines set up this season and any machines below serial numbers 9422120506 and 9422150648 currently being set up, should have the drive wheels removed and the four mounting cap screws checked on both sides of the machine to insure a proper torque of 75 - 100 Ft. Lbs. torque.
