November 2000

### New Wiring Harness

#### Models Affected: All BZT2000's

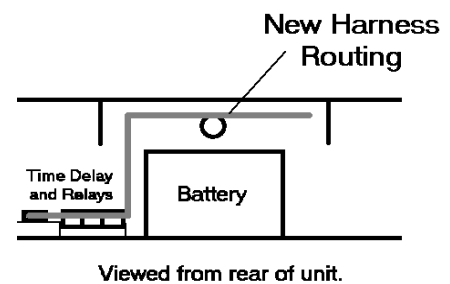
Dwg.1

Viewed from rear of unit.

When replacing a 2188213 harness, you must order a **2721375** harness and a **2721319.7** relay mount. The new harness requires that you re-route it across the top of the frame above the battery and then drop it down along the left-side of the battery (Dwg.1). You will have to install the new relay mount 90 degrees clockwise from the previous location and an additional hole must be drilled in the engine deck (Dwg.2). The new relay mount will also allow for the time delay to be mounted on it.

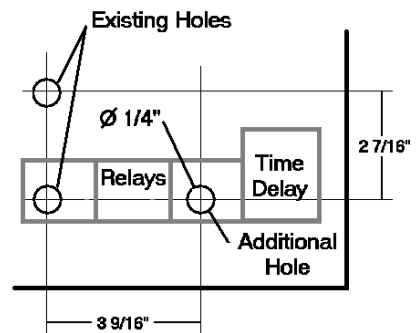
Dwg.2

Viewed from Top Left Front of Unit
