Bobcat/Bunton Service Bulletin

Product Type: LEO PLUS/ESTATE PRO PLUS Ref. No. N/A

Bulletin No: C-024-04

Crankshaft Spacing

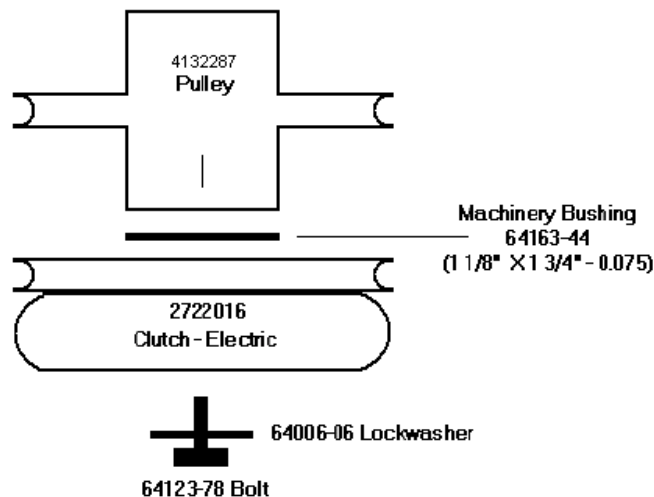
It has come to our attention that the crankshaft spacing may not be correct.

Remove the clutch mounting bolt from the center of the crankshaft. Remove the Clutch 2722016 and install a Machinery Bushing 64163-44 between the clutch and Pump Drive Pulley 4132287. Reinstall the clutch and torque the clutch mounting bolt to 50 ft/lbs.
