February 2003

## Transport Axle Lifting Spring

### Models Affected: All Lawnaire IV and V's

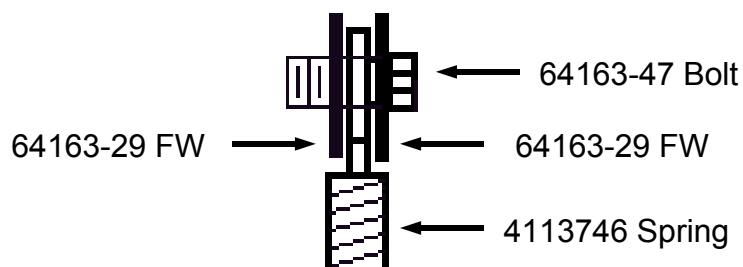
Fig 1.

We have found that in certain conditions the **Lift Transport Springs 4113746** may come off.

You will have to install 2 - **64163-29 Flat Washers**, 1 on each side of the spring and replace the existing bolt with a **64123-47 Bolt**. Fig 1 below.
