Service Bulletin

Brake Disc interference with transaxle Hardware

Date: November 2, 2012

Bulletin No: JC-020-12

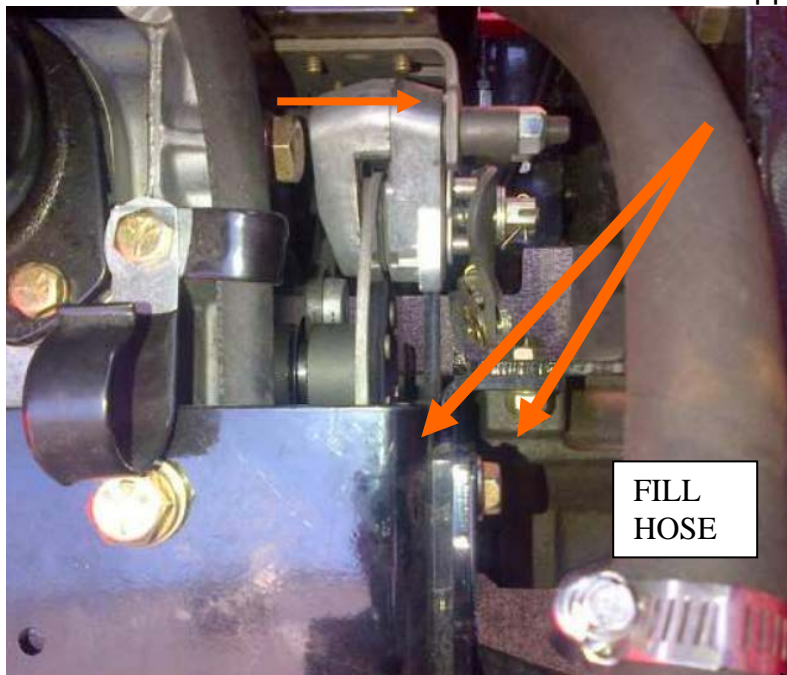
Issue: The new floating brake caliber and brake disc should help reduce brake wear on the Steiner 440. We have discovered that on some tractors the brake disc can float sideways far enough allowing the brake disc to rub the nut of the bolt that holds the transaxle support.

Cause: Too much side travel in the brake caliber and disc.

Action required: Install a locking pin (548602) to restrict the side travel of brake caliber.
