SERVICE BULLETIN

Bulletin No: JC-13-14

Product Type: Steiner 440

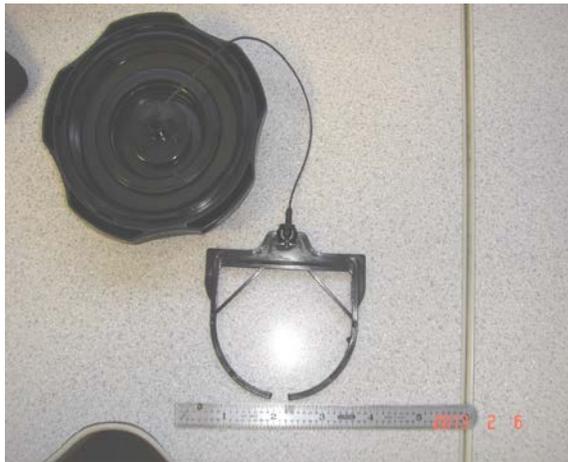
Customer Issue: The fuel tank sending unit float can become hooked on the fuel cap tether. There are certain conditions where this is more likely to occur, such as when operating on slopes and when the fuel tank is 1/4-1/2 full.

Cause: When it does become hooked, the fuel level float will remain at the same level and the fuel gage reading will not change, while the tank level drops, and eventually you run out of fuel.

Action Required: Cut 1/4" to 1/2" (no more than 1/2") out of the center of the bottom of the Tether. If it is tangled, you have to reach in the tank or use a very long tool and unhook the float before pulling out the fuel cap tether.
