## SERVICE BULLETIN

Bulletin No: JC-011-10

### **FASTCAT - SECURING CABLE & HOSE**

**Issue:** Fuel line and Battery cable interference

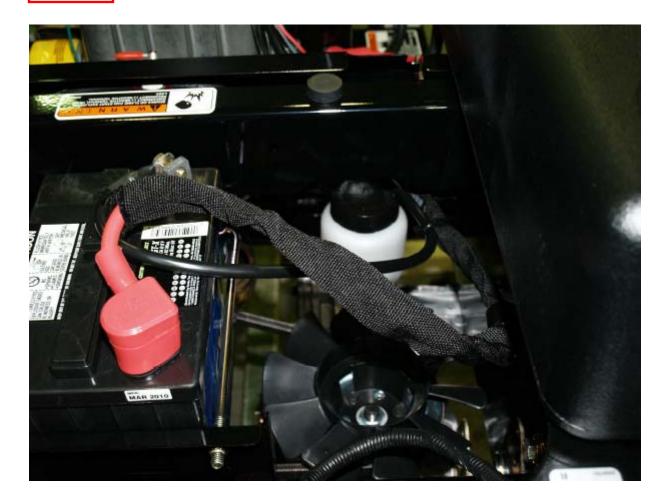
## Figure 1

- 1) Battery cables can be cut into by the transmission fan if not routed upon set-up correctly.
- 2) Fuel line can come in contact with deck pulley.

Note how the cables are facing in toward each other. If they are mounted other than this (including the tie-strap and J clamp) the slack will be unpredictable as to where it ends up and often times this means the cables and fan get damaged.

- BATTERY Upon set-up be sure the battery cables are routed EXACTLY as shown in the first picture below. If routed any other way, the cables can be cut into by the transmission fan. This can result in electrical damage as well as damage to the cooling system.
- 2) FUEL LINE Although remote, it is possible that if enough slack develops in the fuel line above the pulley, the fuel line could possibly be cut by the pulley. This can be avoided with the addition of an extra tie strap as shown in the third, fourth and fifth picture below. Note: all units produced after June 4, 2010 will have the fuel line secured in such a manner as to eliminate this possibility.

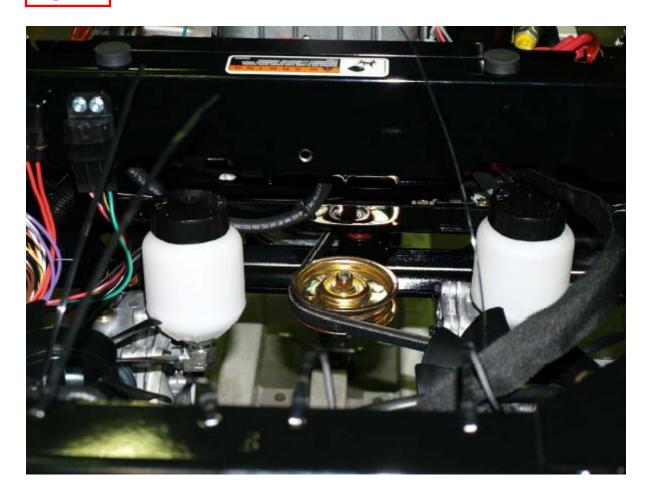
# Figure 2

This is how they typically look. But it is possible for all the slack to be pushed down toward the pulley resulting in the hose contacting the pulley.
