INFORMATION BULLETIN

Bulletin No: JC-012-08

Honda Engines Gas Cap Bulletin

GX120 • GX160 • GX200 FUEL FILLER CAP DOES NOT VENT PROPERLY

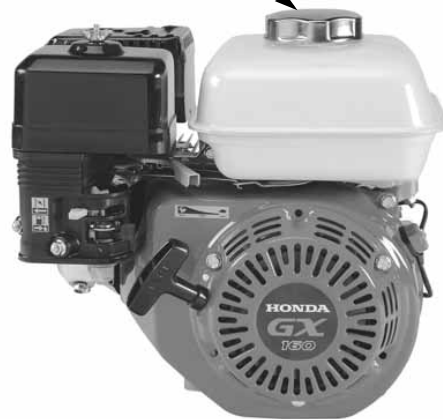
Replace the fuel filler cap with a new style cap. The new style cap can be identified by a notch in the gasket, as shown.

The new style cap has a notch in the gasket.

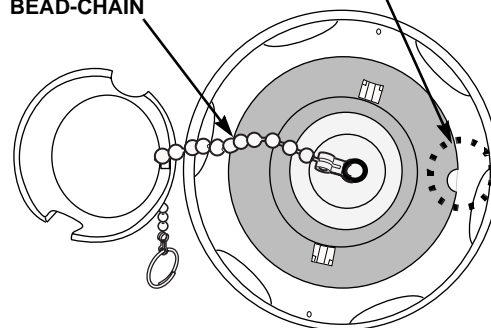
Note that the affected cap tether is the “bead-chain” type, not the flat-chain non-vented cap.
