Service Bulletin

Bulletin No: JC-016-10

Issue: Engine shuts down immediately and will not restart

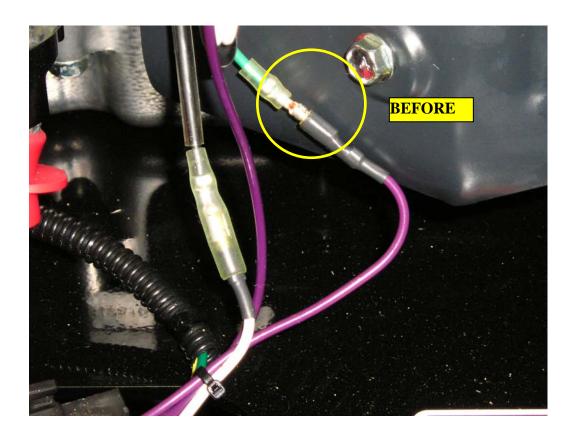
Cause: Wiring harnesses were manufactured without the required boot over the female spade on the (purple) wire to the carburetor solenoid. This exposed connection can touch ground, blowing the fuse on the charge circuit (purple wire fuse holder). The solenoid then shuts off all fuel supply to the engine causing unit to shut down, and not re-start.

Action Required: Pull the wire apart at the connection, slip a 2 inch piece of heat shrink tubing over the wire, reconnect the wire, slide the heat shrink tubing over the connection and heat it to shrink it in place. Replace fuse.
