## **SERVICE BULLETIN**

Bulletin No: JC-018-09

### **Possible wrong nut on 16cc pump pulley – F series BOB-CAT units only**

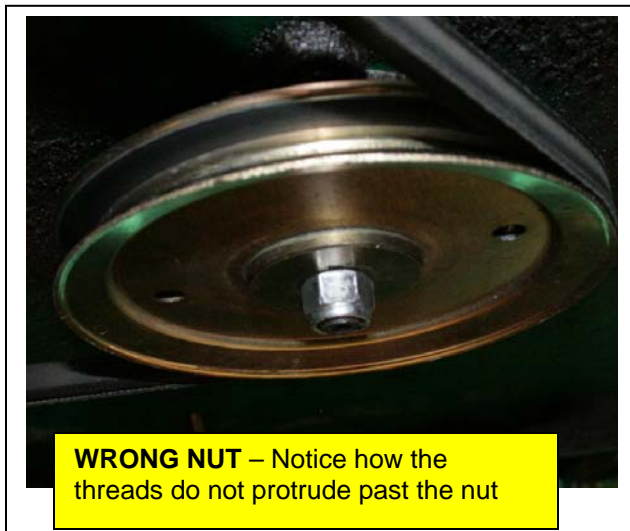
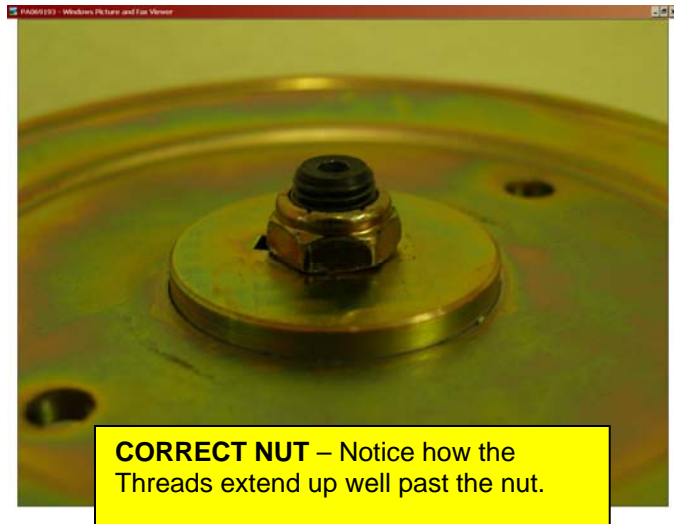
By looking under the mower, you can quickly determine if you are looking at a unit with the wrong nut. If you see the wrong nut and it hasn't come loose yet, be proactive and change out the nut. If you don't have the new nut on hand, at the very least remove the nut, put some blue loctite on it and re-torque to 50ft lbs. It is recommended that you order some of the correct nuts and do the repair right.

If you see the wrong nut, as illustrated in the following pictures, and the pulleys have not worked loose, simply swap out the nut. Torque the new nut to 50ft lbs of torque.

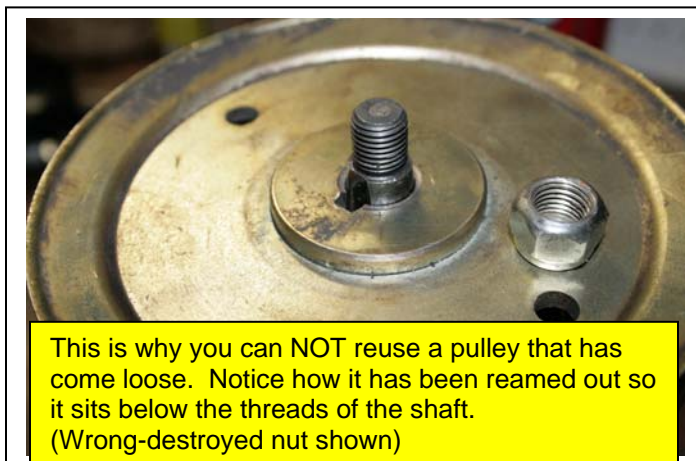
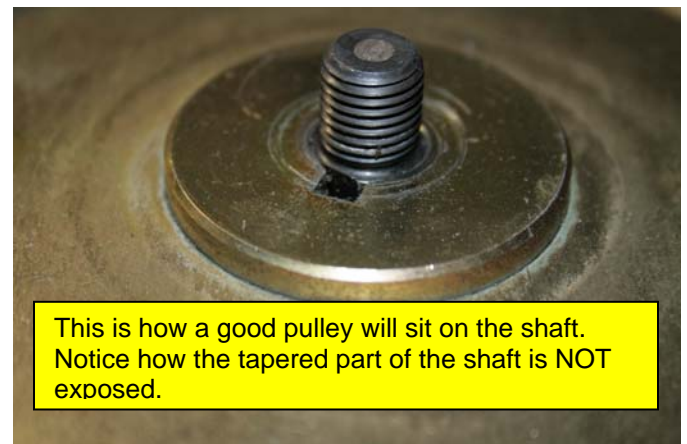
Once the nut comes a little loose, the pulley can rock. This eventually reams out the pulley as it runs. Fortunately the pump shaft is substantially harder than the pulley so the pulley takes most of the abuse. Typically little to nothing happens to the pump shaft. With extended running the key getting hammered in the keyway will take the most abuse. See the following pictures for example of what you can expect to find.

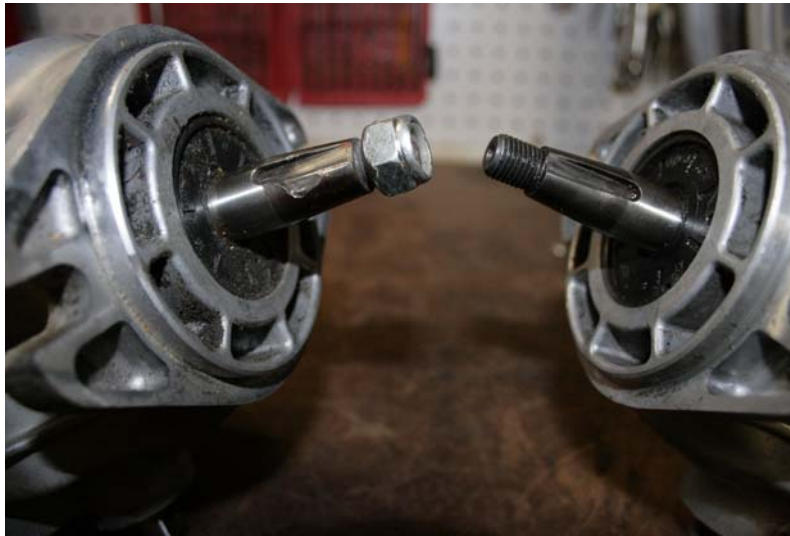
These are typical pictures of the two extremes of pumps we have received back. Both are still 100% functional with no loss in performance or reliability. The one on the right specs out perfect, the dealer was under the false impression that once the pulley came off, the shaft was damaged beyond use – not true. The one on the left has taken much more abuse by the key getting hammered. The fact is, a new pulley will mate perfectly to this shaft, and the pulley is actually held fast to the pump by the friction of the taper (not the key), in the same manner as a flywheel is held in place by the friction of the taper. The key is merely an added measure of safety.

If you experience hammering of the keyway, simply clean up any burr that protrudes above the taper of the shaft, reinstall new pulley, key and nut, torque to 50ft lbs and submit warranty for the repair. If you have damage more extreme than these samples, submit pictures along with your ISN request for consideration of pump replacement. The easy way to tell if the shaft is beyond use is if the taper protrudes up past the NEW pulley.
