Service Bulletin

Bulletin No: JC-020-10

Issue: One of the steering hoses on the 235 could get damaged.

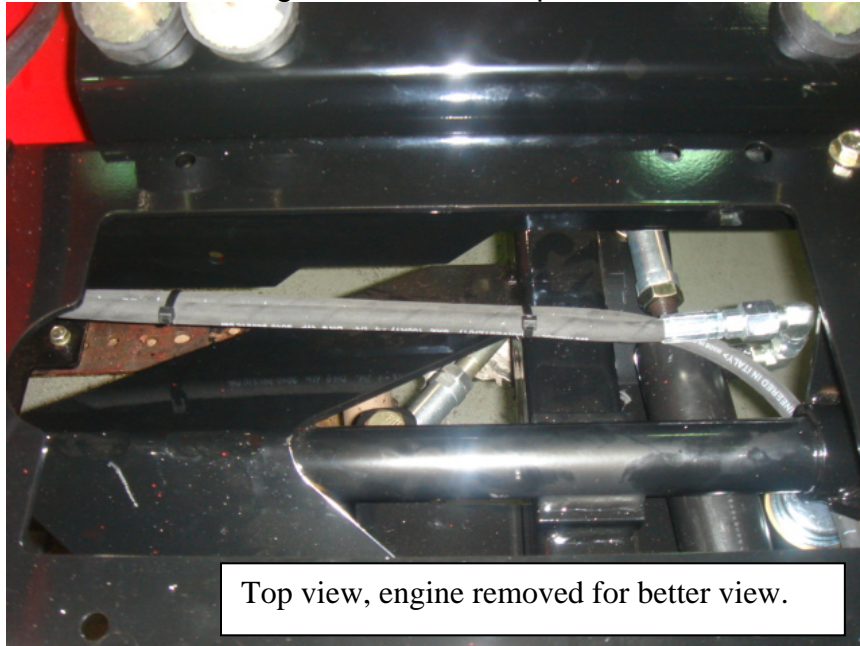
Cause: If both hoses are not tied properly to each other, one hose could fall out between the frame and axle and get pinched when driving over uneven ground.

Action required: Tie both hoses together with tie straps to assure the hose cannot get pinched.
