Service Bulletin

Bulletin No: JC-023-10

Issue: Premature belt failure

Products Involved: Steiner snow blowers **75-70666** (SB448) and **75-70667** (SB454)

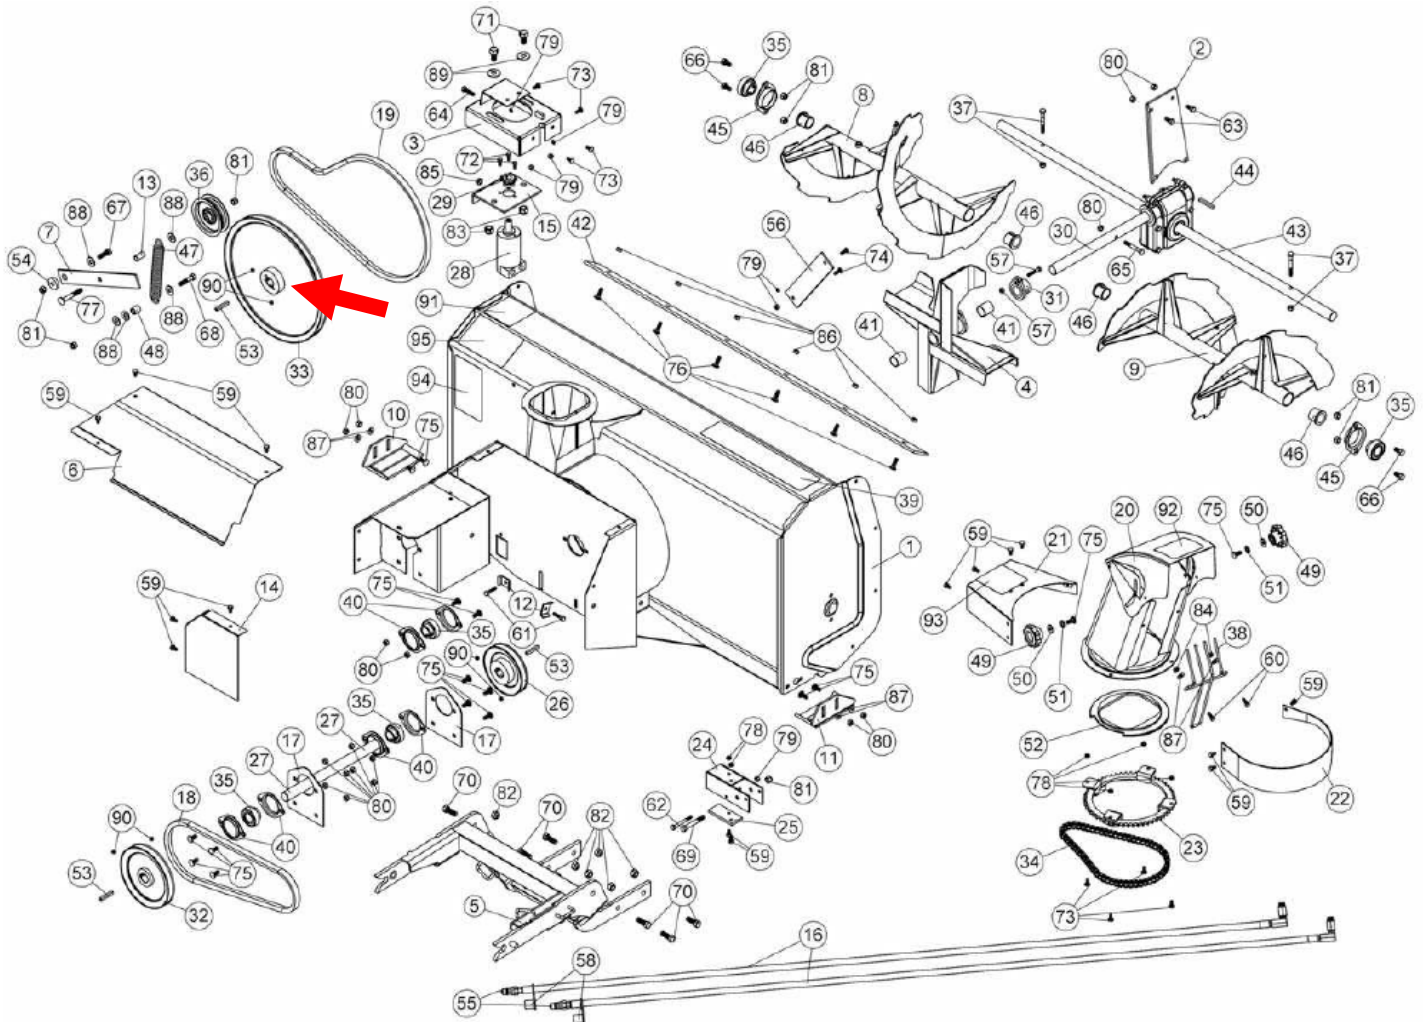
Typical Illustration

Cause: Fan pulley 4165810 set screws are not tight and can slide on the shaft misaligning belt and allowing the belt to rub on the frame. (See illustration on page two)

Action required: Remove the shield and look at the set screws, you will see red loctite® on the screws and shaft if they are correct. Absence of the red loctite® means the set-screws need to be removed, loctite® applied and reinstalled. Realign pulley if necessary.
