Service Bulletin

Bulletin No: JC-19-03

Product Type: BOB-CAT Zero Turn mowers

Customer Issue: Battery drains quickly or unable to start mower

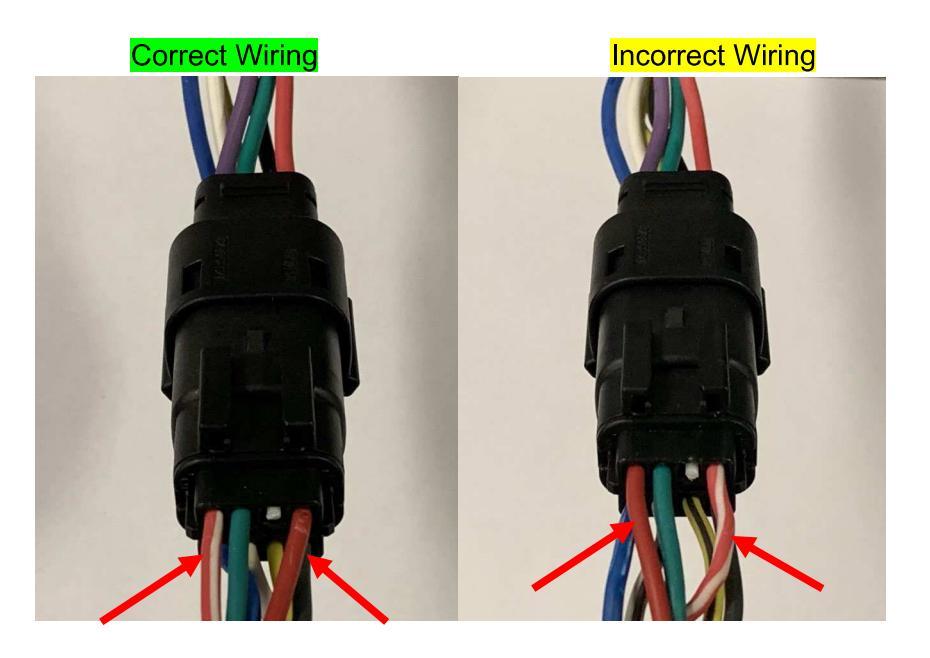
- 1. <u>During setup at the dealership</u>, inspect the engine wiring harness connector for switched wires. This can be done one of two ways:
 - a. Hook up battery and see if the hour meter comes on when the key is in the Off position. If the hour meter displays any information with the key off, the wires noted are likely switched. This would apply to inspecting new units being uncrated.
 - b. Inspect the engine wire harness where it connects to the main harness (between the engine and seat). The red wire should be next to the blank receptacle and the red wire with white stripe should be next to the green wire. See below for correct wiring.

c. If you find the wires are reversed, please replace the engine harness (P/N 4176255).
