SERVICE BULLETIN

Bulletin No: JC-13-18

Product Type: STEINER

Products Involved: 440 Kubota powered tractors: 75-72010 and 75-72011.

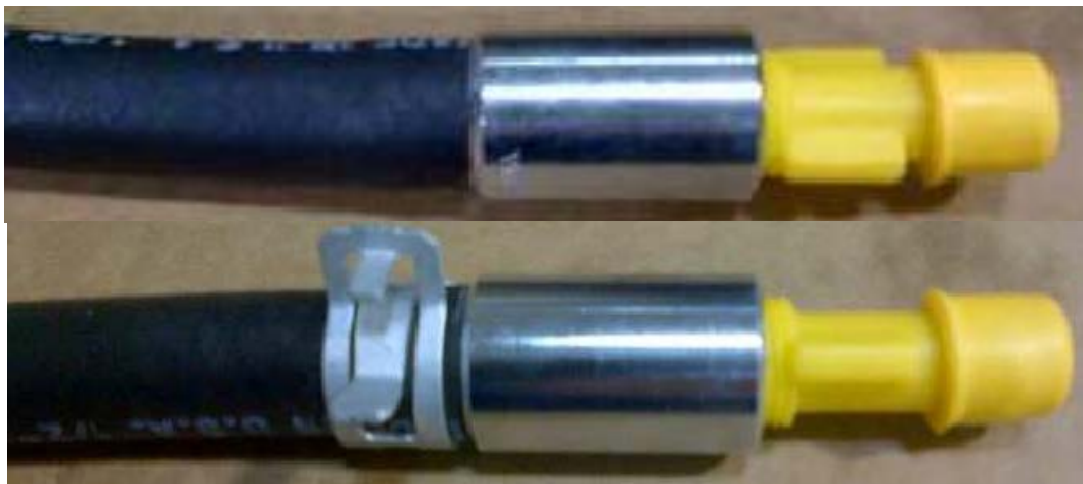
Customer Issue: The valve on the end of the Kubota engine oil drain hose can be removed too easily and cause a possible oil loss.

Cause: There is no hose clamp to hold the valve tight in the hose.

Action required: Install a hose clamp on the engine oil drain hose.

7572010 Kubota diesel tractors order a hose clamp: 88042-05

7572011 Kubota gas tractors order a hose clamp: 88042-03
