Service Bulletin

Bulletin No: JC-002-11 **Mandatory Quality Update**

Product Type: G series-ProCat and Predator-Pro (52 and 61 inch models).

2011 G Series Lift Lever Replacement Instructions

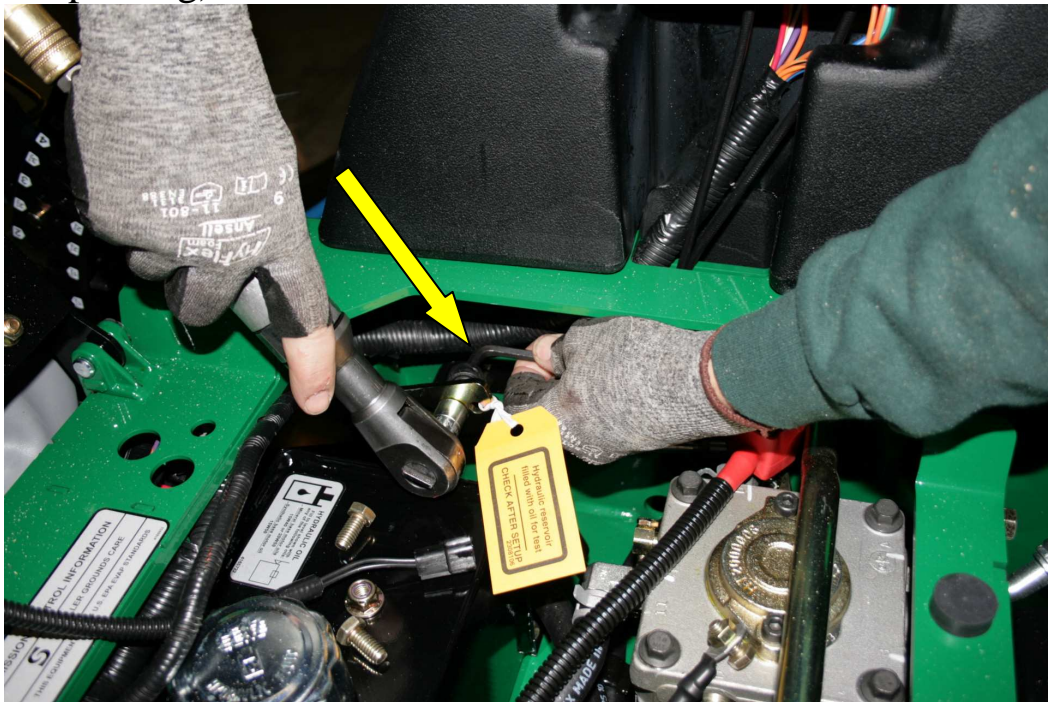
- 1) Lift the seat, use a ½ socket to remove the nut from the dampener arm (the ball socket of the dampener uses a T30 to hold it from spinning)

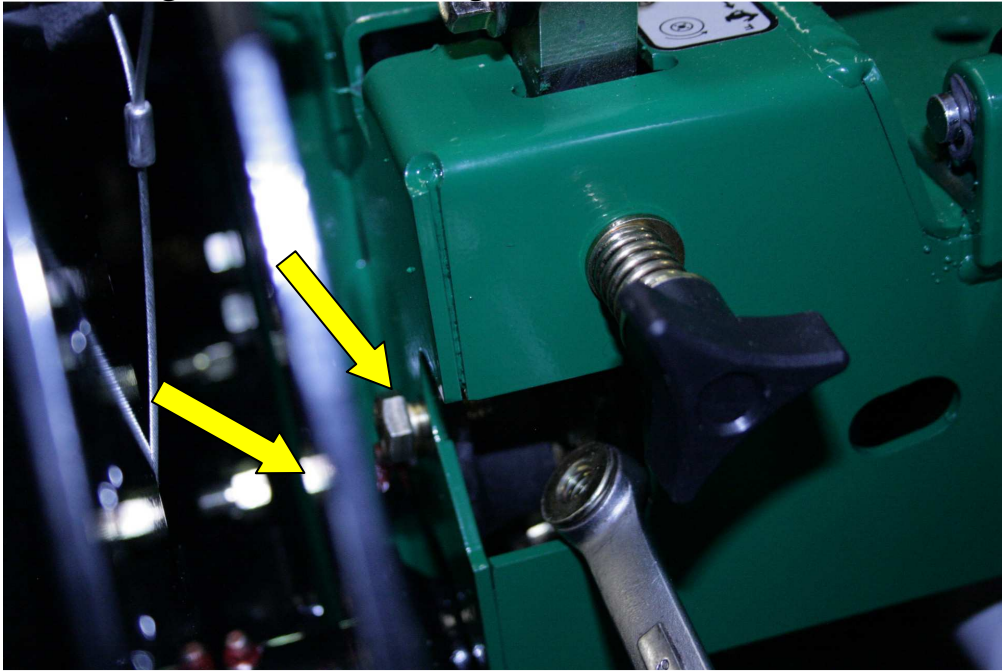
2) Use a 9/16 socket and 9/16 box end wrench to remove the two bolts holding the outer bushing of the control arm.

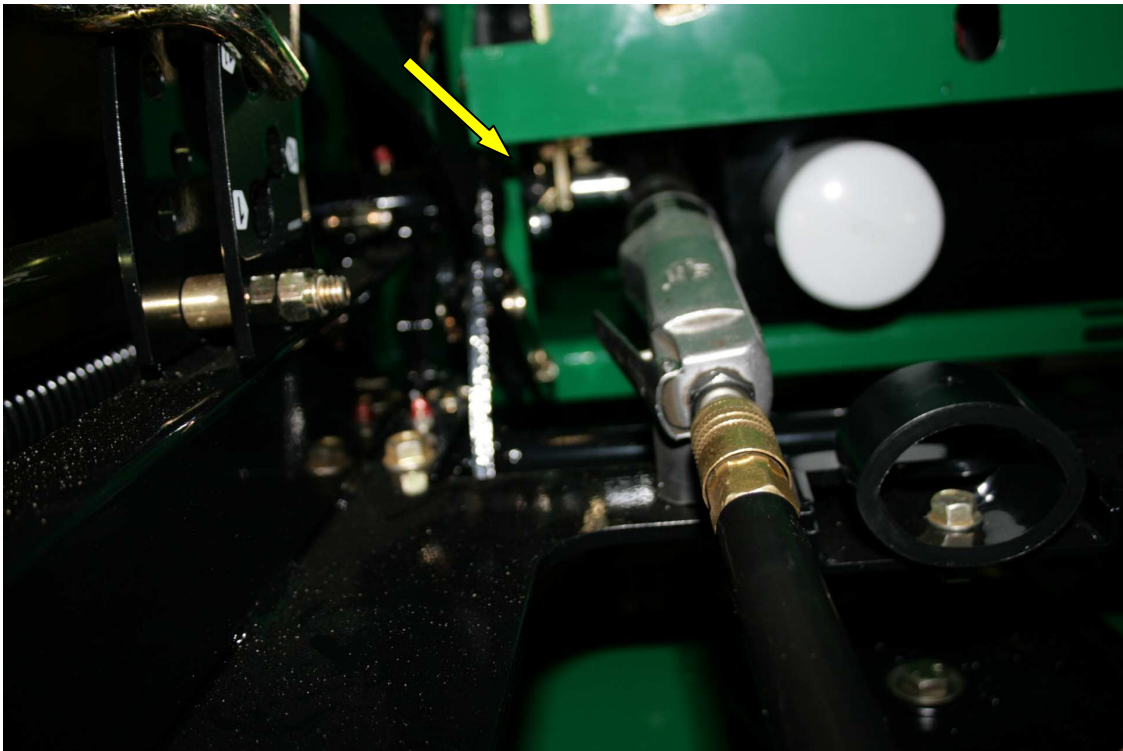
3) Put the seat back up, lift the foot pan. Take a 1/2" socket and 5/16" open end wrench and remove the nut from the ball socket of the control rod.

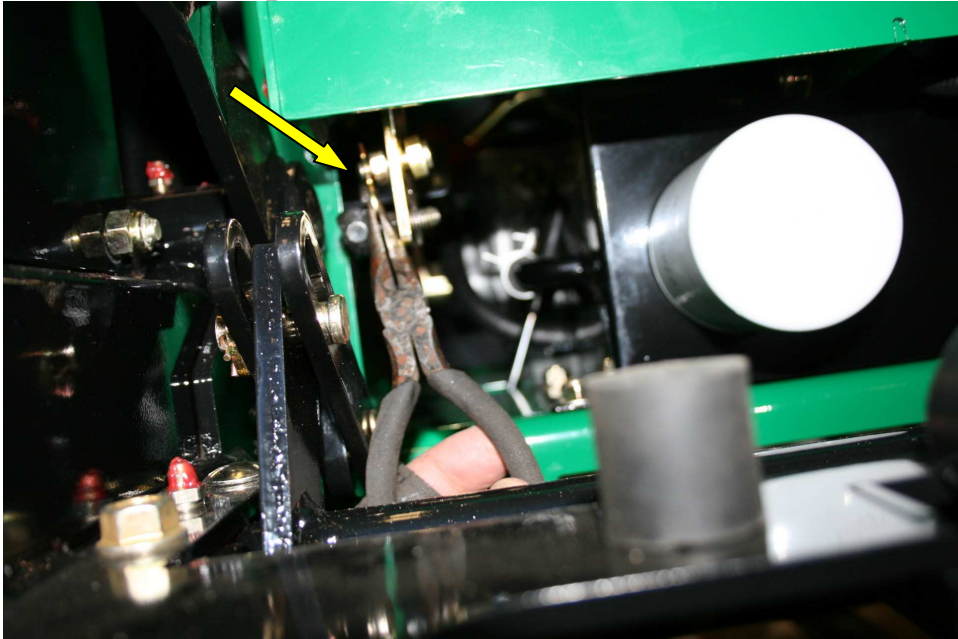
- 4) Take Needle nose pliers and remove four cotter pins – one in the pin of the reverse link. Remove the pin as well. Notice control rod is not yet removed. It is easier to remove it once you get the pin out as you can push the entire control arm assembly down and get clearance to pull it out.

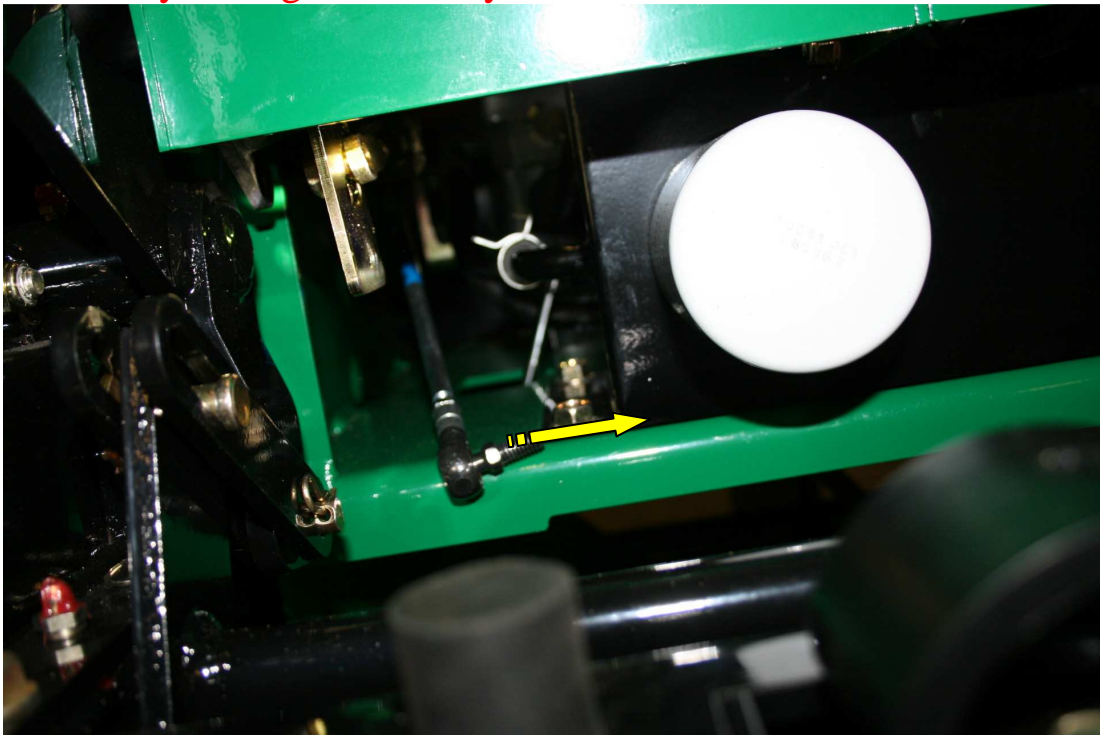
Once pin is removed and you have removed the control rod ball joint, **put the ball joint up against the oil tank...this is important or it will get in the way during reassembly.**

- 1) **FIRST before anything else, Install the Stovehead bolt in the lower hole of the detent selector (that way the lift rod doesn't block the hole).**
- 2) **Put the pump control rod ball joint in before you mount it to the frame so you have room to get it back in the hole.**
- 3) **You'll most likely have to reset the tracking on the RH side of the unit.**

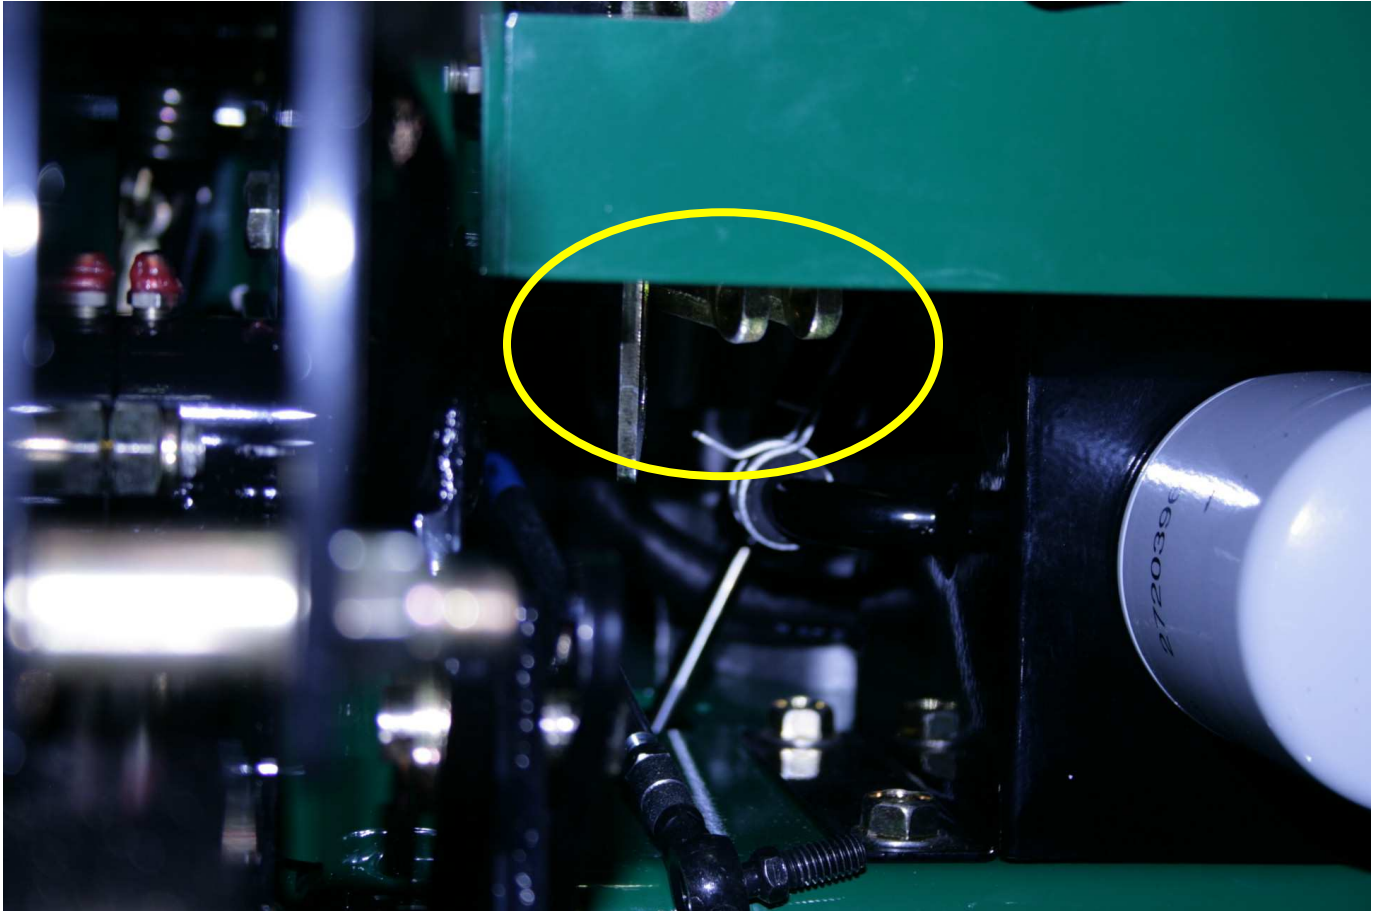
Important – To get the required clearance to get the old Lift Arm out, we have to get the spring loaded reverse link tucked inside (toward the oil tank) the control arm.

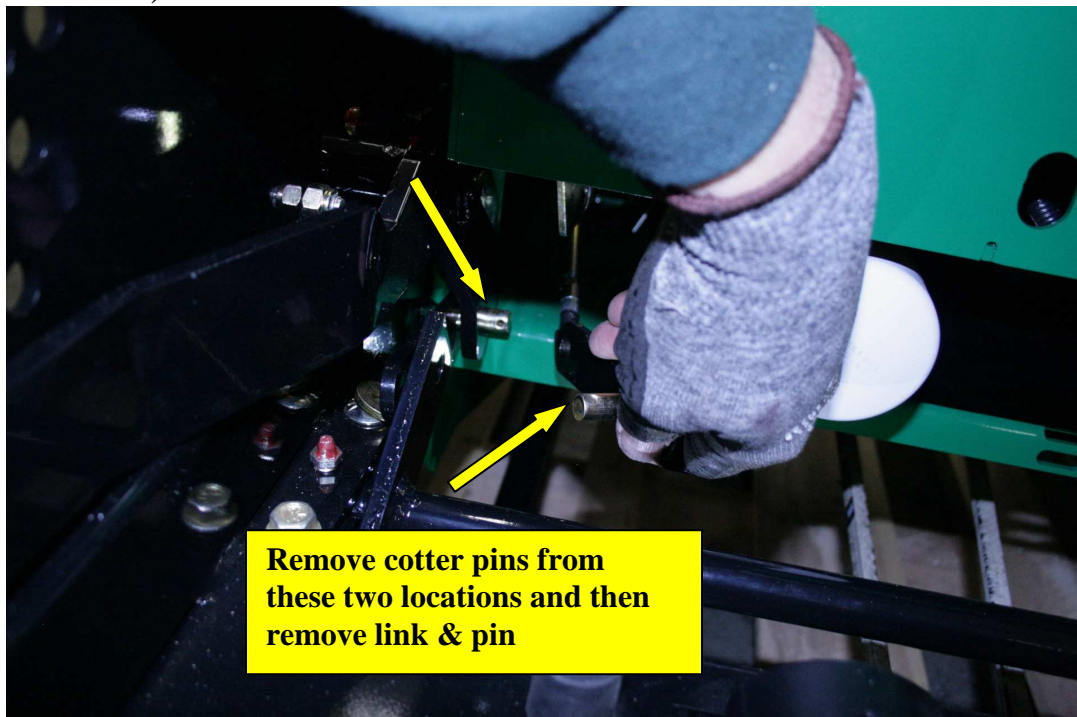
5) Remove two more cotter pins in the lift links. Note the outer link can be removed but the inner one requires the Lift Arm to slide partially out before it can be removed. (on reassembly to make it easier, just put the pin in from the other direction after the Lift Arm is installed)

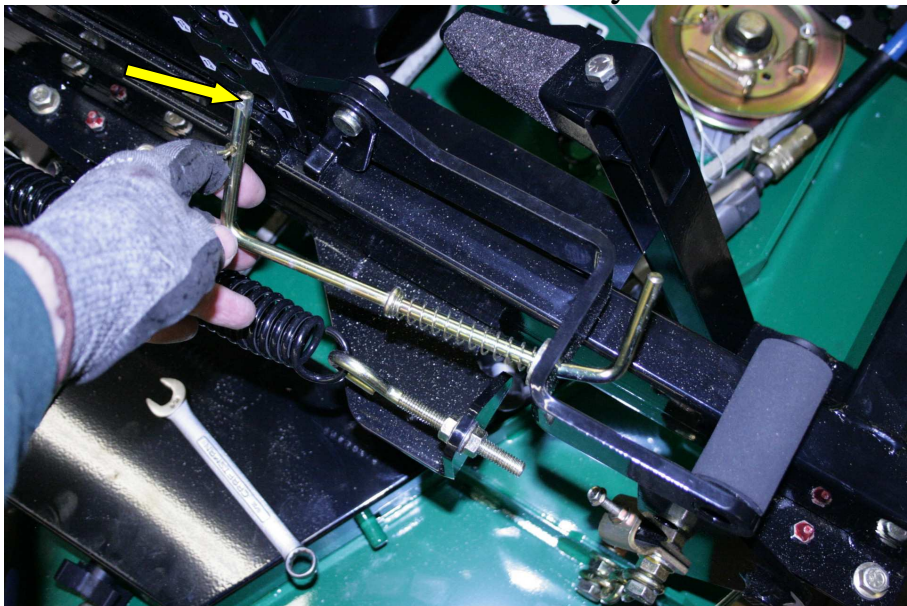
5) Remove the cotter pin from the inside of the spring loaded lift handle. And remove the assembly from the Lift Arm.

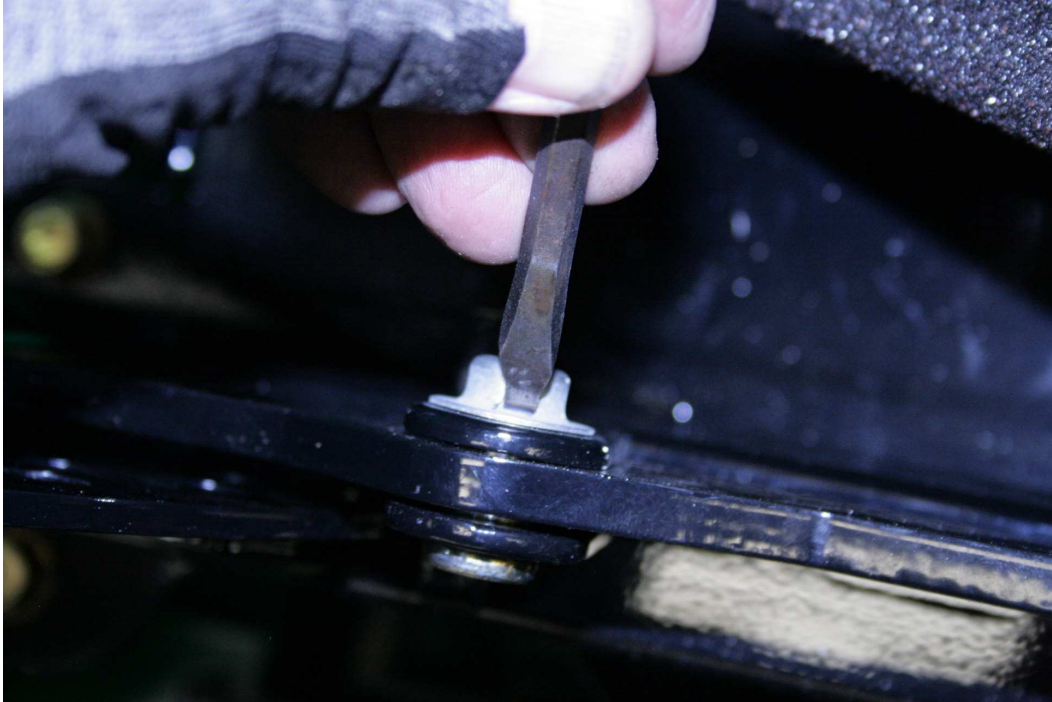
- 6) Take a flat blade chisel and hit the Push Nut sharply on the two areas where you see the tabs. The Push Nut should come right off if you hit it sharp enough.

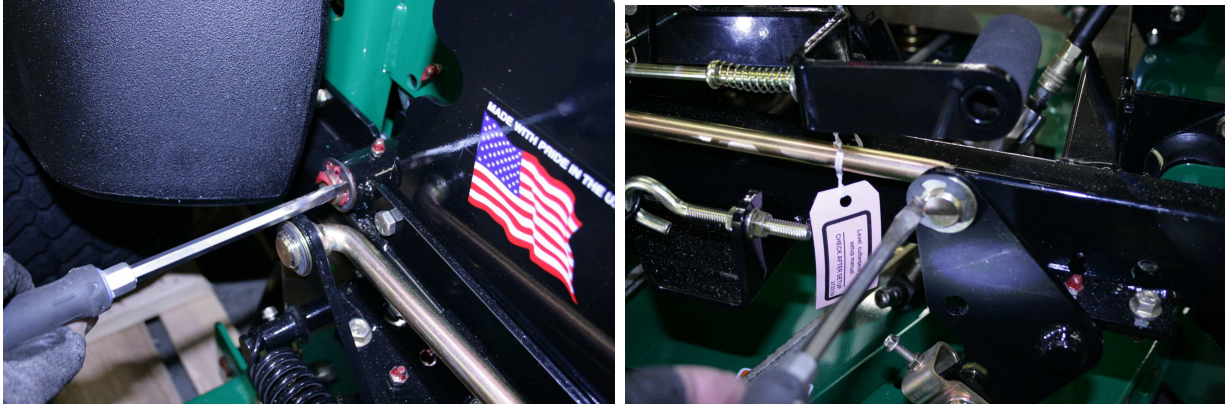
- 8) Take a wide blade flat screwdriver and pop the “E” clips off the Pivot for the Lift Arm and the front Lift Rod.

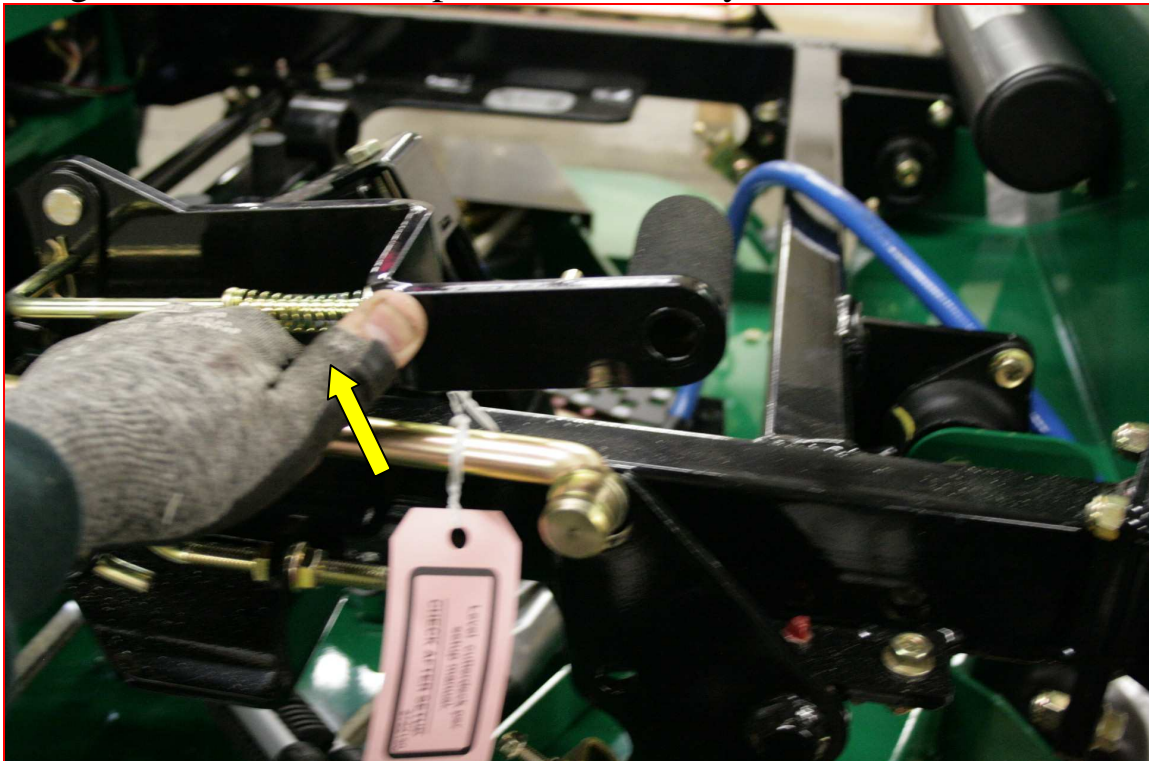
- 9) You need to get the lift rod out of the way. Push it out of the front hanger and while pulling out on the lift rod and pushing in on the Lift Lever, you can get them past each other. Pivot the lift rod up against the tank to keep it out of the way.

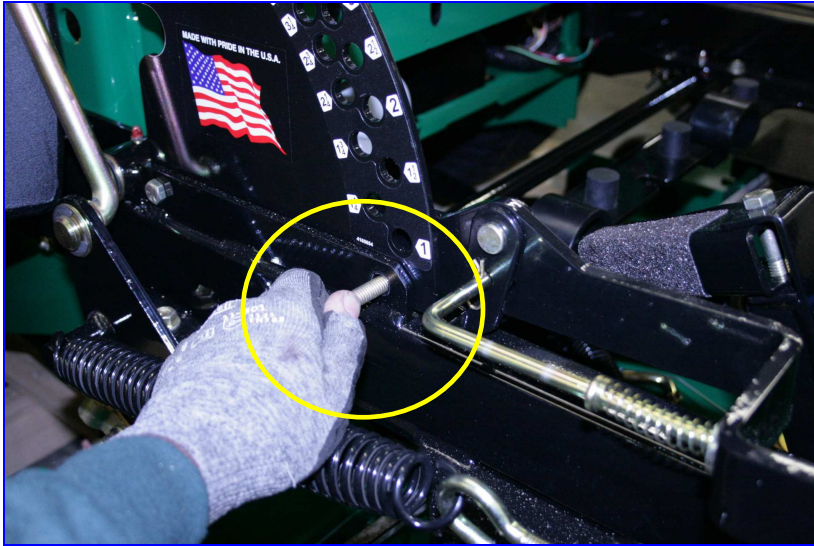
Now remove the Stovehead bolt (it needs to be removed for clearance reasons)

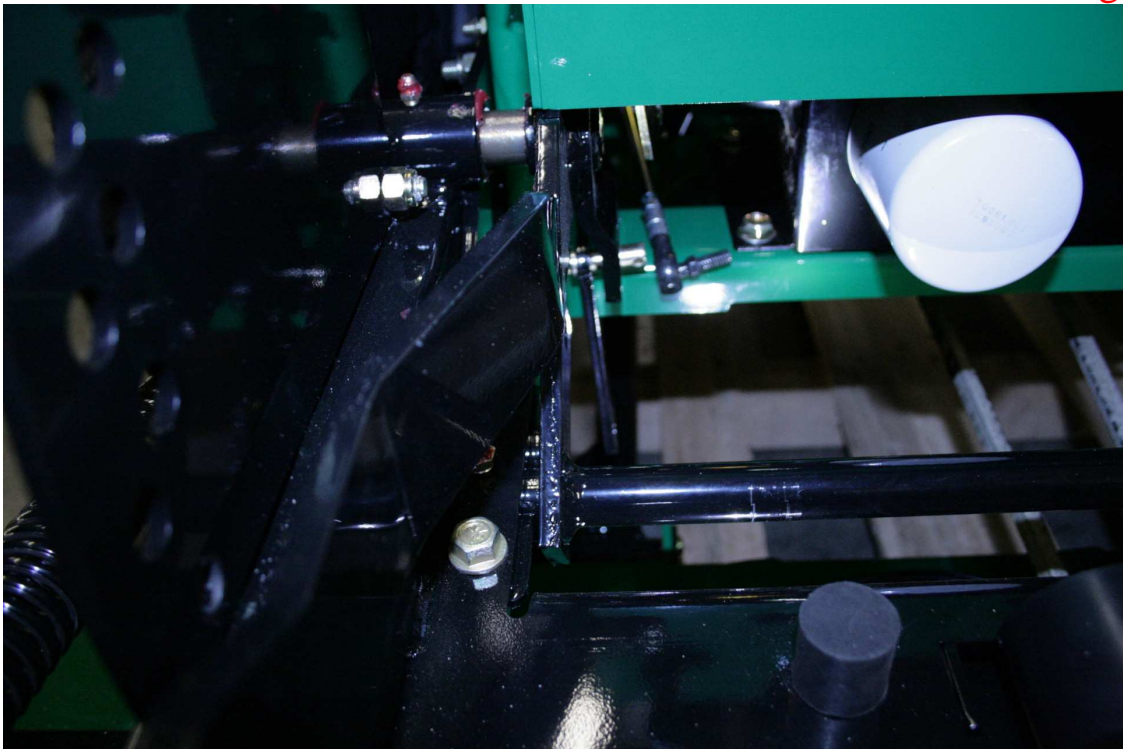
10) We can now remove the Lift Lever. With Foot lever folded out of the way start working the Lift Lever out. Note the inner link and pin will fall out once you move it a little. You may have to pull on the foot pedal to get it to clear the Lift Lever **as well as put the control handle in the forward position off its slot and pull down on it as the ISO mount and control arm will interfere with it coming out.**

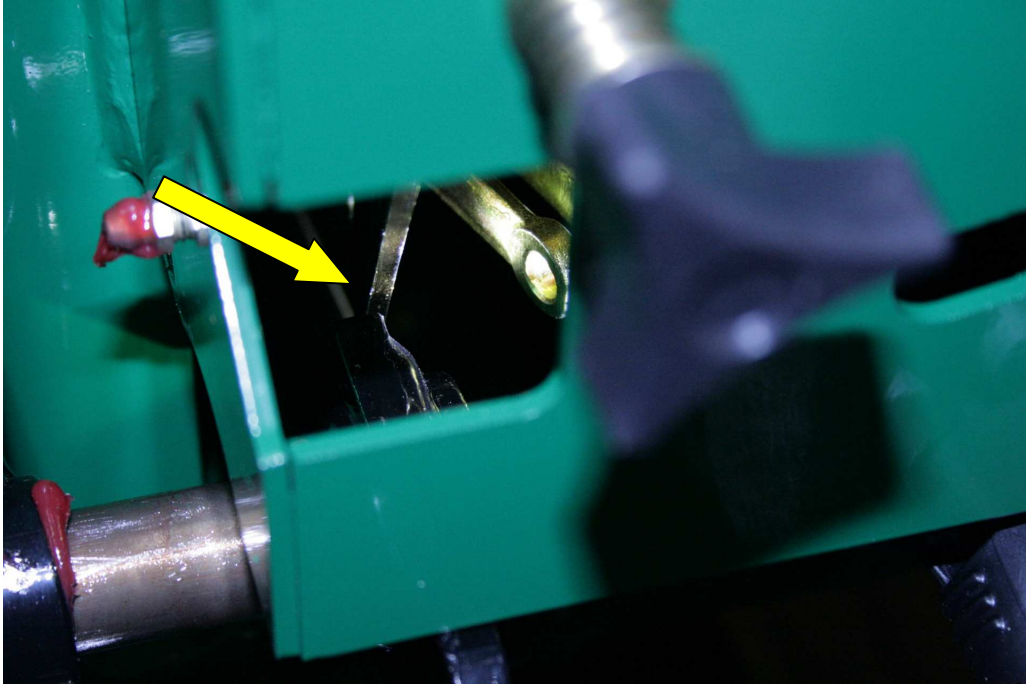
See in the picture below how you have to pull forward on the control lever to get the needed clearance

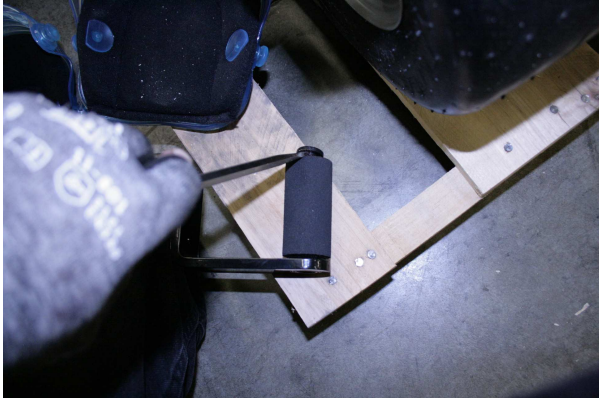
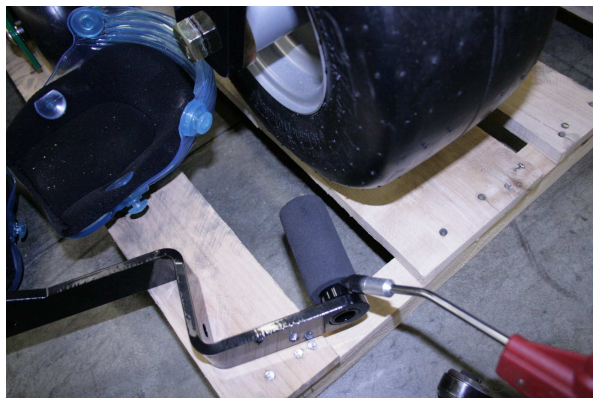
11) We need to remove the grip and cap from the lever so we can reuse it on the new lever. Simply put a flat blade screwdriver between the cap and lever and pop it out. Take an air nozzle and force air under the grip and it will slide right off.

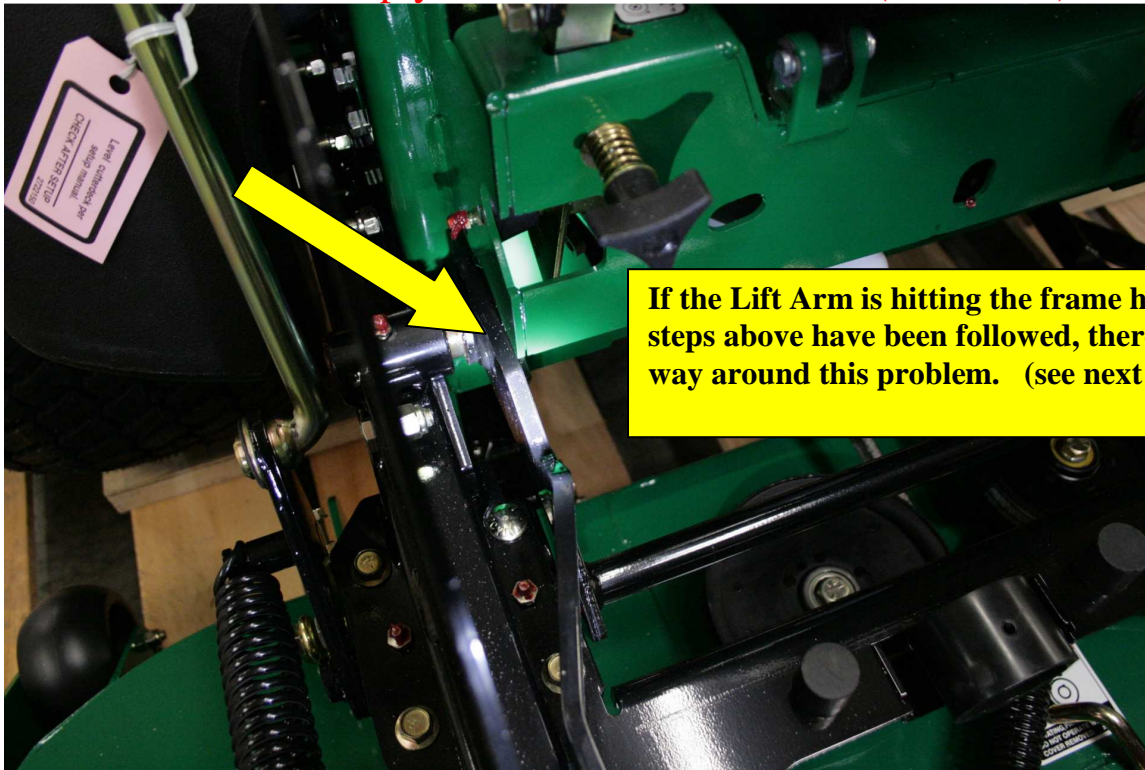
There is the possibility that normal “tolerance stack-ups” can result in a Lift Arm that will simply not clear the main frame (see below)

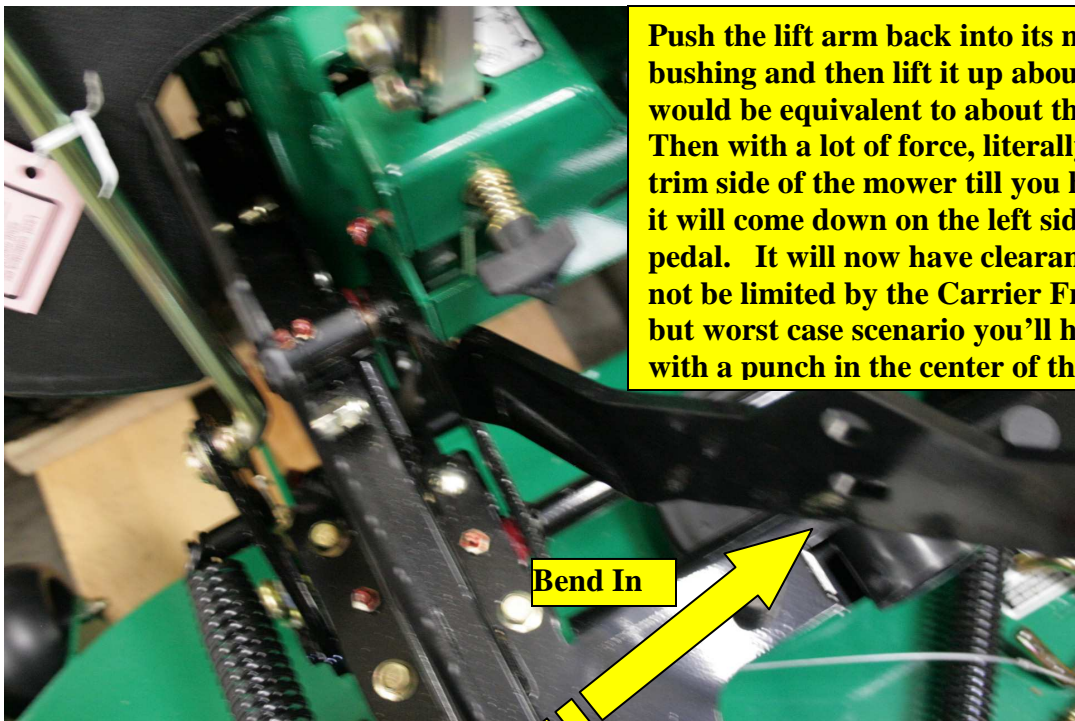
If the Lift Arm is hitting the frame here after all steps above have been followed, there is only one way around this problem. (see next picture)

Push the lift arm back into its normal position in the bushing and then lift it up about half way...what would be equivalent to about the 3” height of cut. Then with a lot of force, literally bend it in toward the trim side of the mower till you have bent it so far that it will come down on the left side of the foot assist pedal. It will now have clearance to come out as it will not be limited by the Carrier Frame anymore (rare – but worst case scenario you’ll have to hammer it out with a punch in the center of the pivot shaft).

If this type interference occurs, you will have to use a rubber mallet to reinstall the new one as the main box will be contacting the new Lift Arm.
