SERVICE BULLETIN

Bulletin No: JC-011-11REV1

Product: G Series ProCat and Predator-Pro models.

Issue: Lower Seat Cushion Tearing

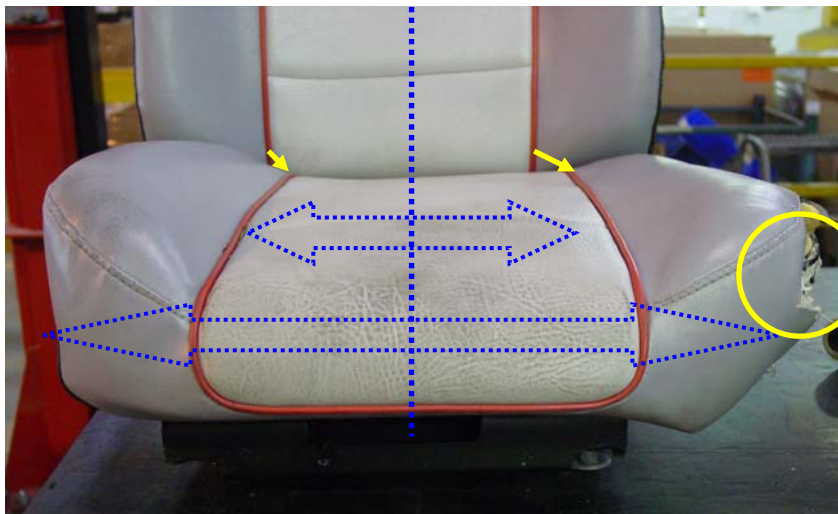
Revision 1: Cause #2- Lower Seat not manufactured to engineering specifications causing misalignment and seat base shifting that can cause seat tearing. See image below.

Notice that the seat base above is off to one side, the red piping on the lower seat cushion does not line up with the piping on the back cushion and the seat base has torn from rubbing against the control arm.

Action Required Cause #2: If you encounter a misaligned **Cause #2** seat with tearing (like shown above), complete replacement of the seat assembly (#4165316) is required. Please order a replacement through your local distributor.

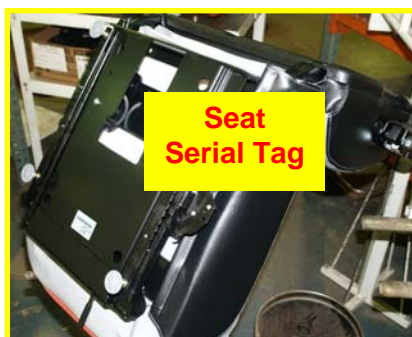
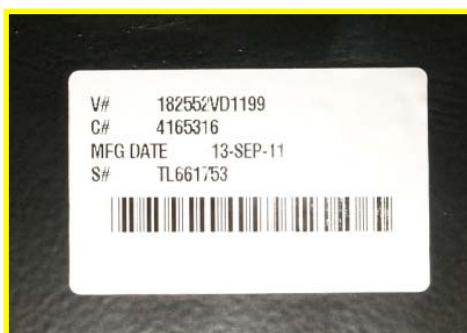
1. Mower Serial Number
2. Photo of the seat from a front view (see page 1)
3. Photo of Seat Serial Tag (as shown below)

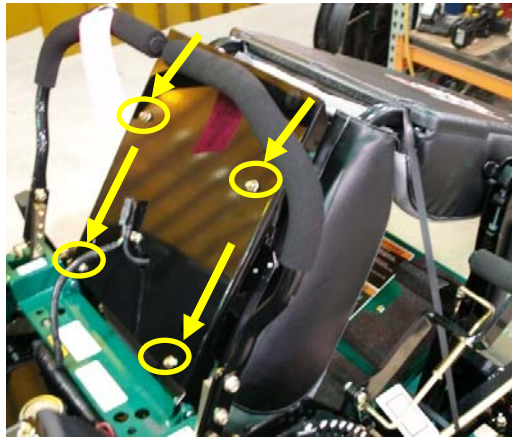
Note: The serial plate is located on the bottom of the actual seat, not the seat pan you see when you flip the seat forward. Remove the seat from the seat pan to see the serial tag.
