## SERVICE BULLETIN

Bulletin No: JC-011-10

### **FASTCAT - SECURING CABLE & HOSE**

**Issue:** Fuel line and Battery cable interference

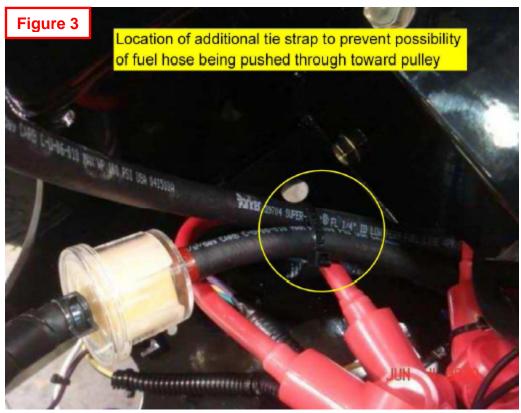
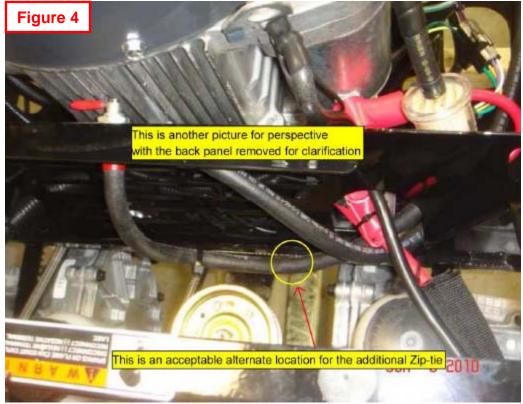
- 1) Battery cables can be cut into by the transmission fan if not routed upon set-up correctly.
- 2) Fuel line can come in contact with deck pulley.

- BATTERY Upon set-up be sure the battery cables are routed EXACTLY as shown in the first picture below. If routed any other way, the cables can be cut into by the transmission fan. This can result in electrical damage as well as damage to the cooling system.
- 2) FUEL LINE Although remote, it is possible that if enough slack develops in the fuel line above the pulley, the fuel line could possibly be cut by the pulley. This can be avoided with the addition of an extra tie strap as shown in the third, fourth and fifth picture below. Note: all units produced after June 4, 2010 will have the fuel line secured in such a manner as to eliminate this possibility.
