**Bob-Cat**

Product Type: ZT200 Ref. No. 013

## New Wiring Harness

**Models Affected:**  
**All ZT200's**

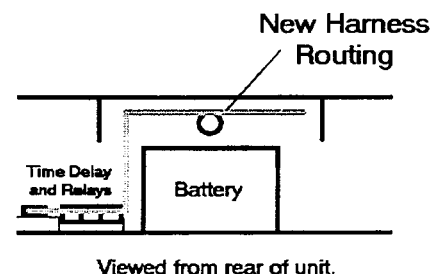
Dwg.1

The new harness requires that you re-route it across the top of the frame above the battery and then drop it down along the left-side of the battery (Dwg.1). You will have to install the new relay mount 90 degrees clockwise from the previous location and an additional hole must be drilled in the engine deck (Dwg.2). The new relay mount will also allow for the time delay to be mounted on it.

When replacing a 2188163 or 2188213 harness, you must order a **2721375** harness and a **2721319.7** relay mount.
