SERVICE BULLETIN

Bulletin No: JC- 011-12

Product Type: G series 72" Predator-Pro and ProCat decks

Issue: Missing washer(s) between spindle and pulley

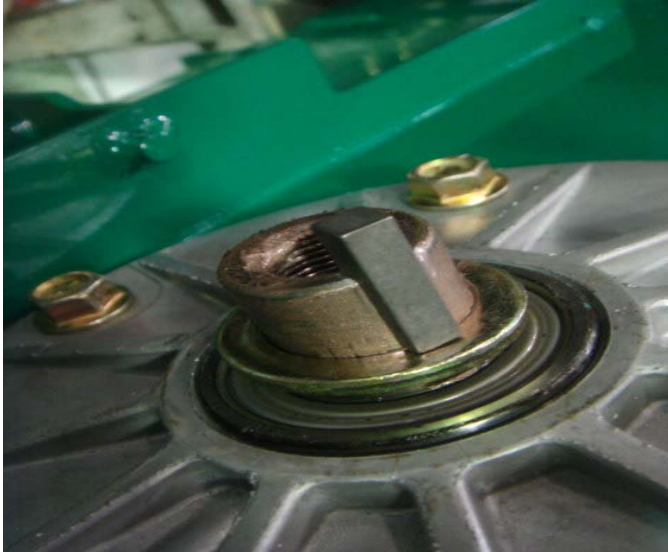
Generac units get one washer installed per spindle

Action Required: Please install the appropriate number of washers (**Part #: 64163-68**) between the spindle housing and pulley.

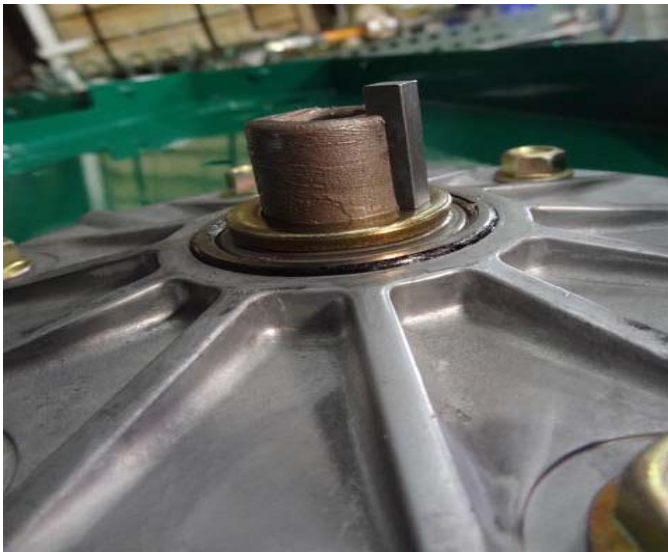
Kawasaki and Kohler units get two washers installed per spindle
